Re: Notification of Closure by Removal - City of Columbia Water & Light Department
Inactive CCR Surface Impoundment (More's Lake)

This letter report, prepared by Burns & McDonnell on behalf of the City of Columbia (City), provides notification of closure by removal of CCR material, a summary documentation of the CCR removal activities, and groundwater monitoring data.

Client: City of Columbia
Project Location: More's Lake, Columbia, Missouri
Project Number: 93647
Report: CCR Removal

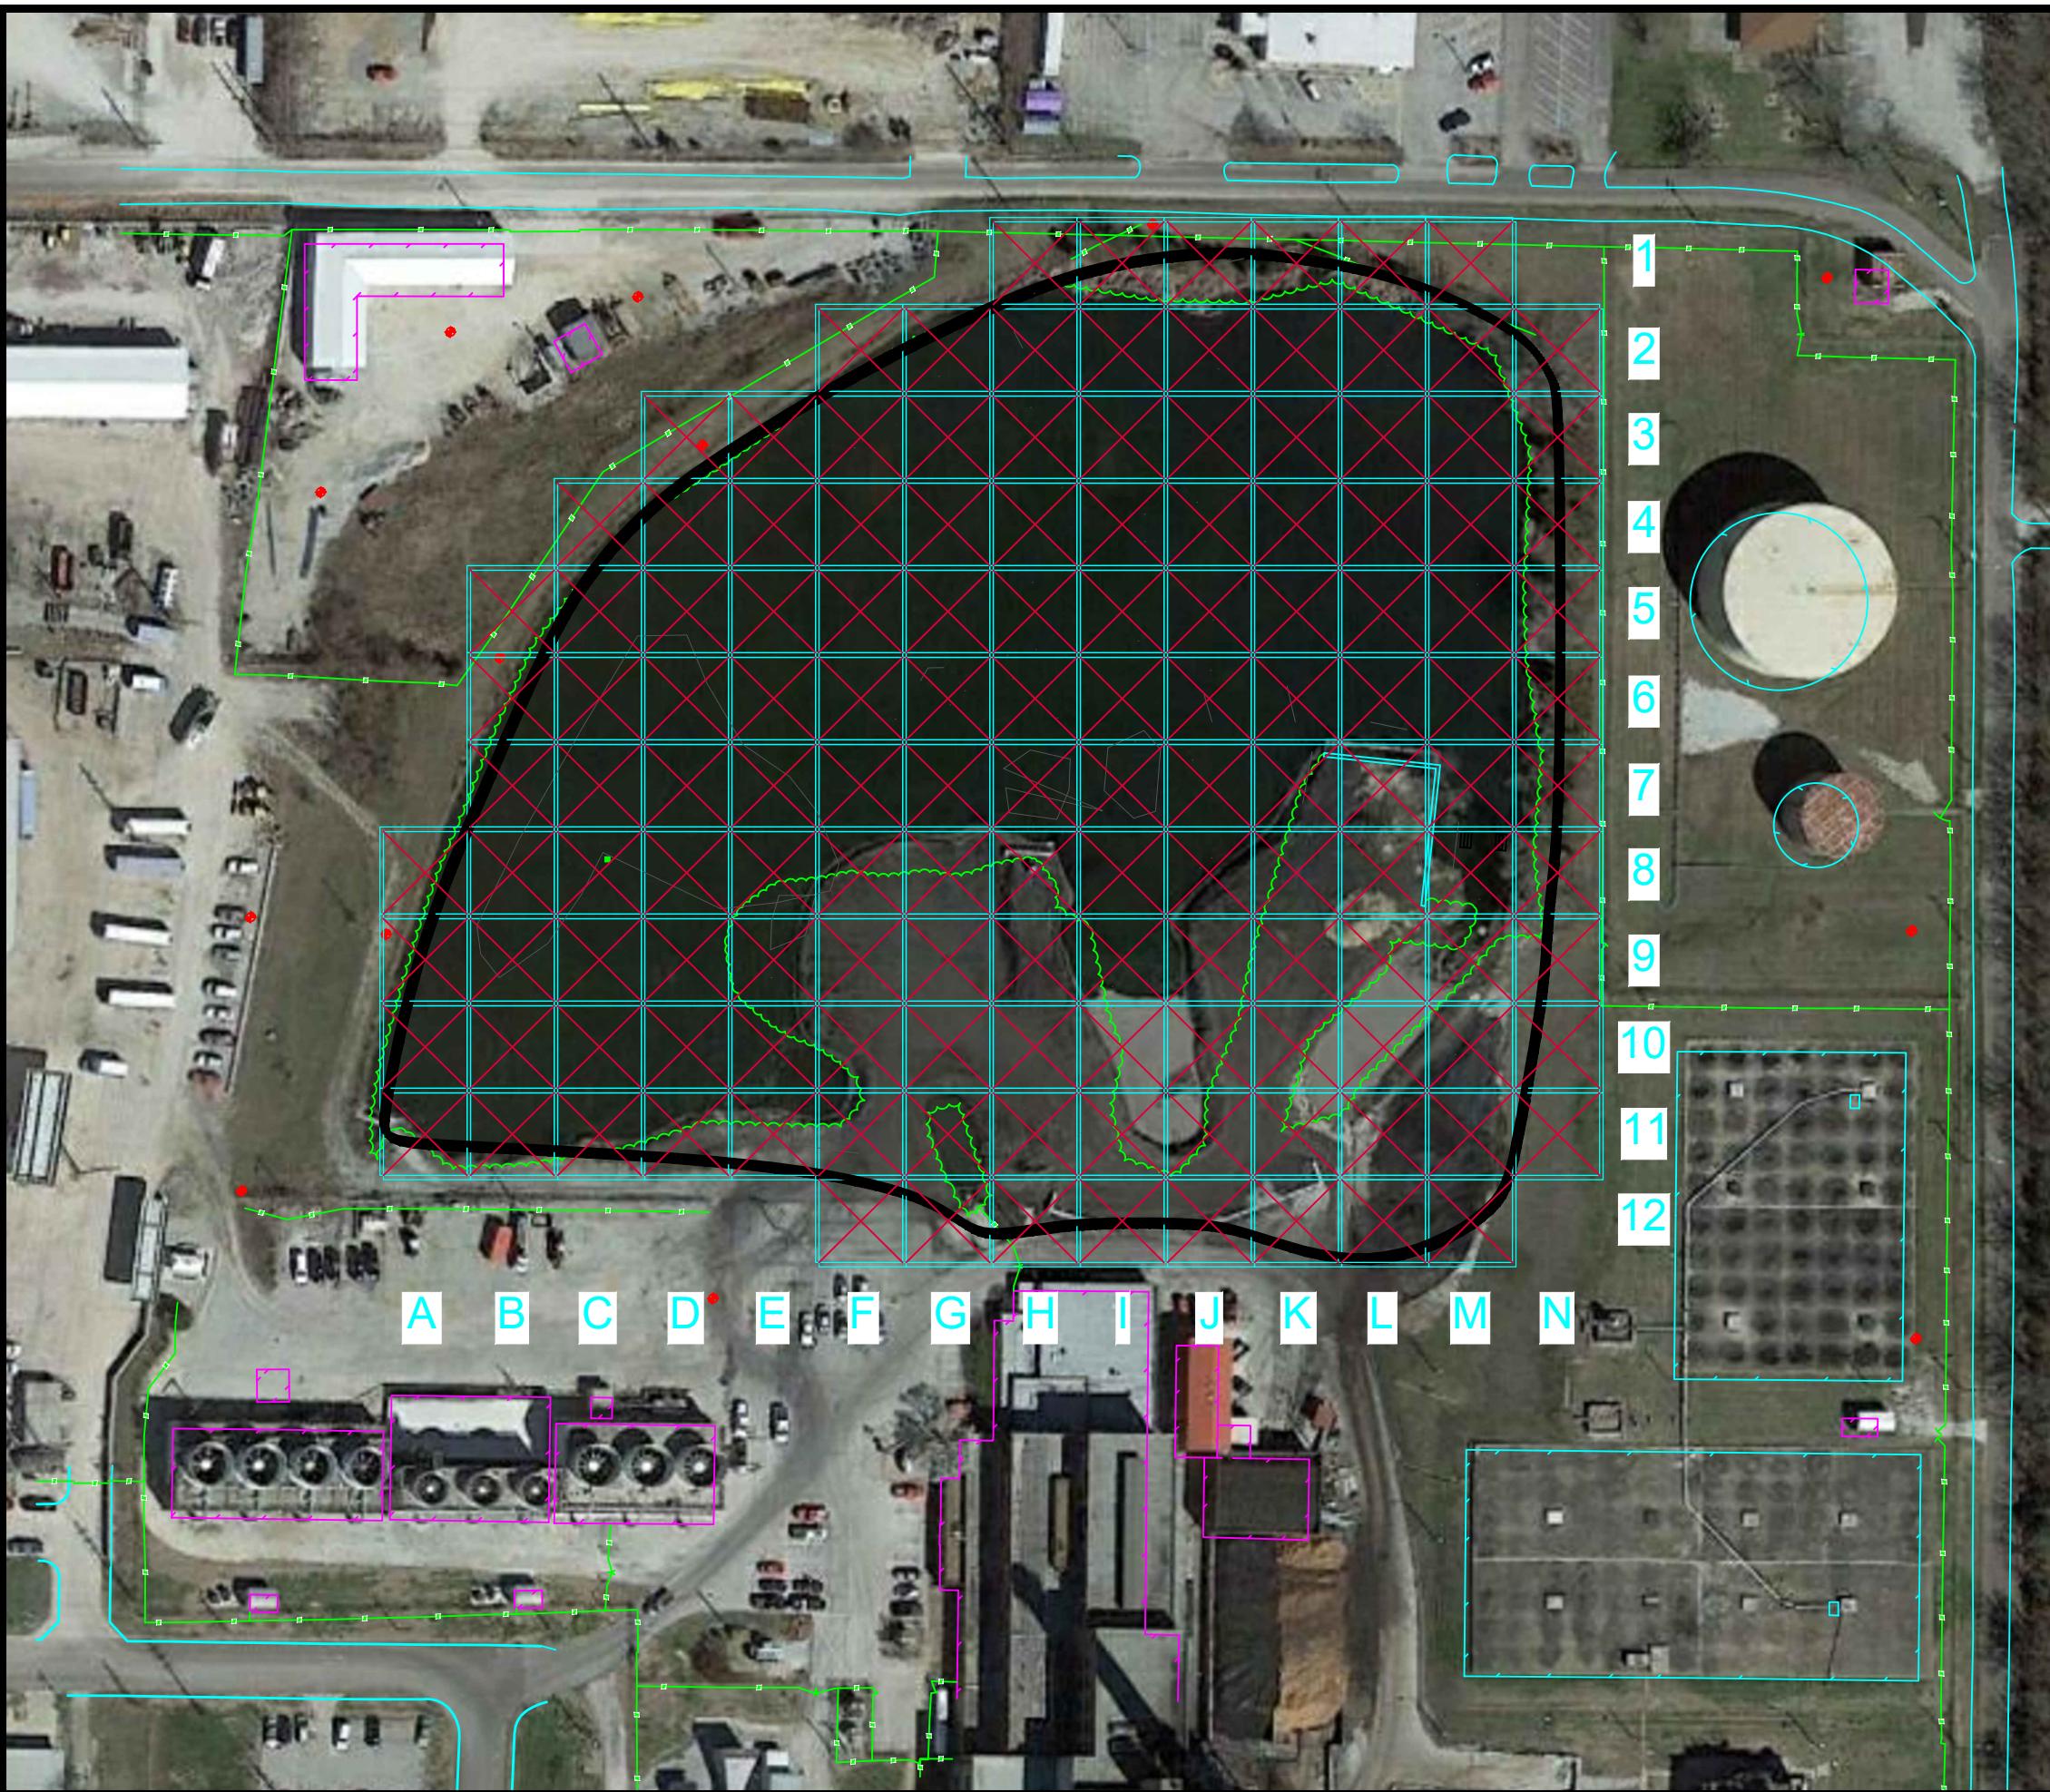
FIGURE 1
MAY 14, 2019
VISUAL INSPECTION GRID
COLUMBIA MUNICIPAL POWER
PLANT
COLUMBIA, MISSOURI

In the winter and spring of 2019, the City continued removal of residual CCR in the identified locations as well as in other areas previously stockpiled or submerged under water in the ponded sump area. In May of 2019, the City contacted Burns & McDonnell to resume the CCR removal verification inspections. Due to the extended time and work completed since the previous inspections, Burns & McDonnell approached the 2019 inspections assuming no grids had been previously cleared. The first inspection of 2019 took place on May 14, 2019. The same procedure was performed as described above with visually identified CCR flagged in the field and logged on the grid map. Nine relatively small, isolated locations were flagged during this inspection and several grids were submerged under the ponded water surface. Following this inspection, an updated map figure was provided to the City, showing the isolated locations where visual CCR remained and the submerged grids that were not inspected. This figure is provided in Attachment 1 (Figure 1). The next inspection took place on May 30, 2019, during which final CCR residual material locations were flagged in the field for removal. The City completed the removal of the CCR material at the identified areas over the next day. On May 31st the final inspection was made to verify all CCR material flagged the previous day had been visually removed. Figure 2 in Attachment 1 reflects the final inspection completed on May 31, 2019 with all grids cleared.

- LEGEND**
- GRID AREA
 - HISTORICAL SURFACE IMPOUNDMENT BOUNDARY
 - X VISUALLY INSPECTED AND CLEARED FOR MATERIAL REMOVAL
 - INDICATES GRID HAS OBSERVED CCR MATERIAL (LOCATION FLAGGED DURING INSPECTION)
 - INDICATES GRID HAS YET TO BE CLEARED DUE TO RETAINED WATER
